**Investigation into the
Performance of an Automatic Fire Sprinkler System
at a Medium Density Fibreboard Plant**

T. G. O'Brien, BE (Hons), MSFPE, MFPANZ, MIEEE

November 2006

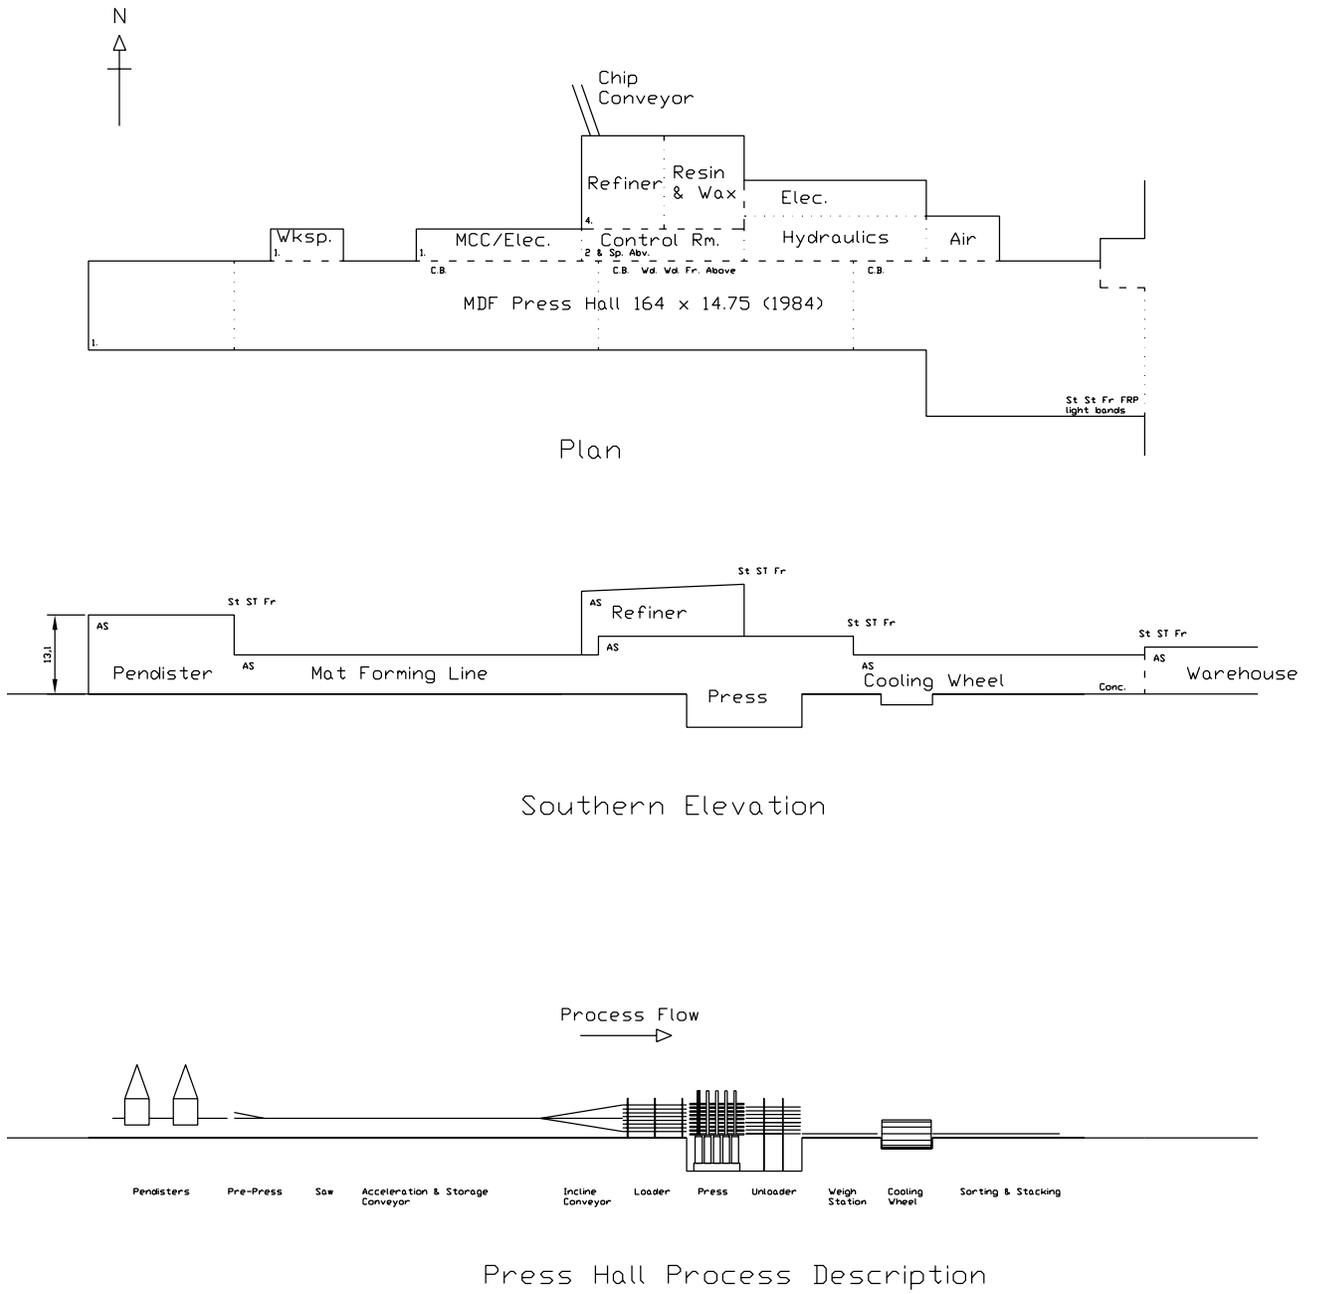
Figure 1. Press Hall Plan, Elevation and Process Description

- 3.2 There are two similar refiner lines, one for wood chip and one for sawdust. The chip/sawdust is delivered to the refiner tower where it is converted to fibre by mechanical shear between rotating plates in two Sunds defibrators and one Hymac 63" refiner. The fibre is mixed with formaldehyde resin and wax and injected at high velocity into one of two blow lines located external to the press hall building. The fibre is dried by heated air in the blow lines, and separated from the (now moist) air stream by cyclone dryers. The dried fibre is transported to one of two pendisters at the western end of the press hall. Refer to the Press Hall Process Diagram in Figure 1. The pendisters lay down

- 4.1 A plan and elevation of the MDF process buildings is attached at Figure 1. The MDF press hall was constructed of steel cladding on steel portal frames with a concrete floor. The walls had fiberglass reinforced plastic skylight bands at the eaves. The hall was 162 m long (from the pendister to the end of the sorting table) by 14.75 m wide. Roof heights varied over the process areas as follows: pendister: 13.1 m; mat forming line: 6.5 m; press: 9.6 m, cooling wheel: 6.5 m.

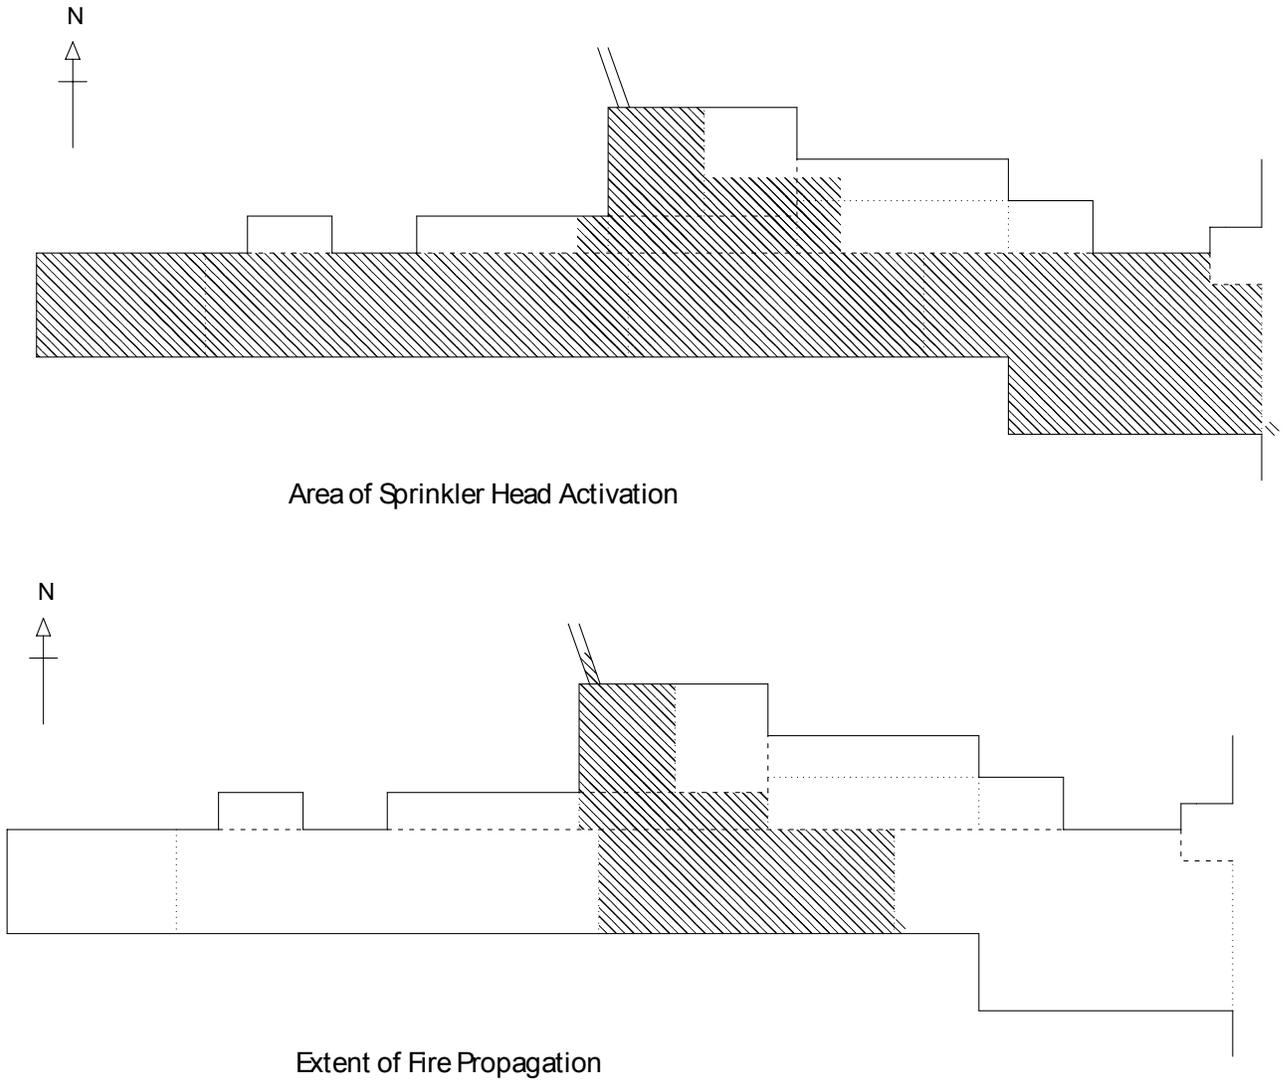
Figure 2. Plans Showing Areas of Sprinkler Head Activation and Fire Propagation

7.1 Refer to Figure 2 for plans showing the extent of fire propagation and automatic sprinkler head activation. Automatic sprinkler heads had fused in the following areas: throughout the press hall extending from the pendister to the eastern end of the cooling wheel, around the perimeter of the press pit and beneath the press hood, on the southern face of the refiner tower at levels one and three, in the control room and the instrument room below. Approximately 300 sprinkler heads had activated.

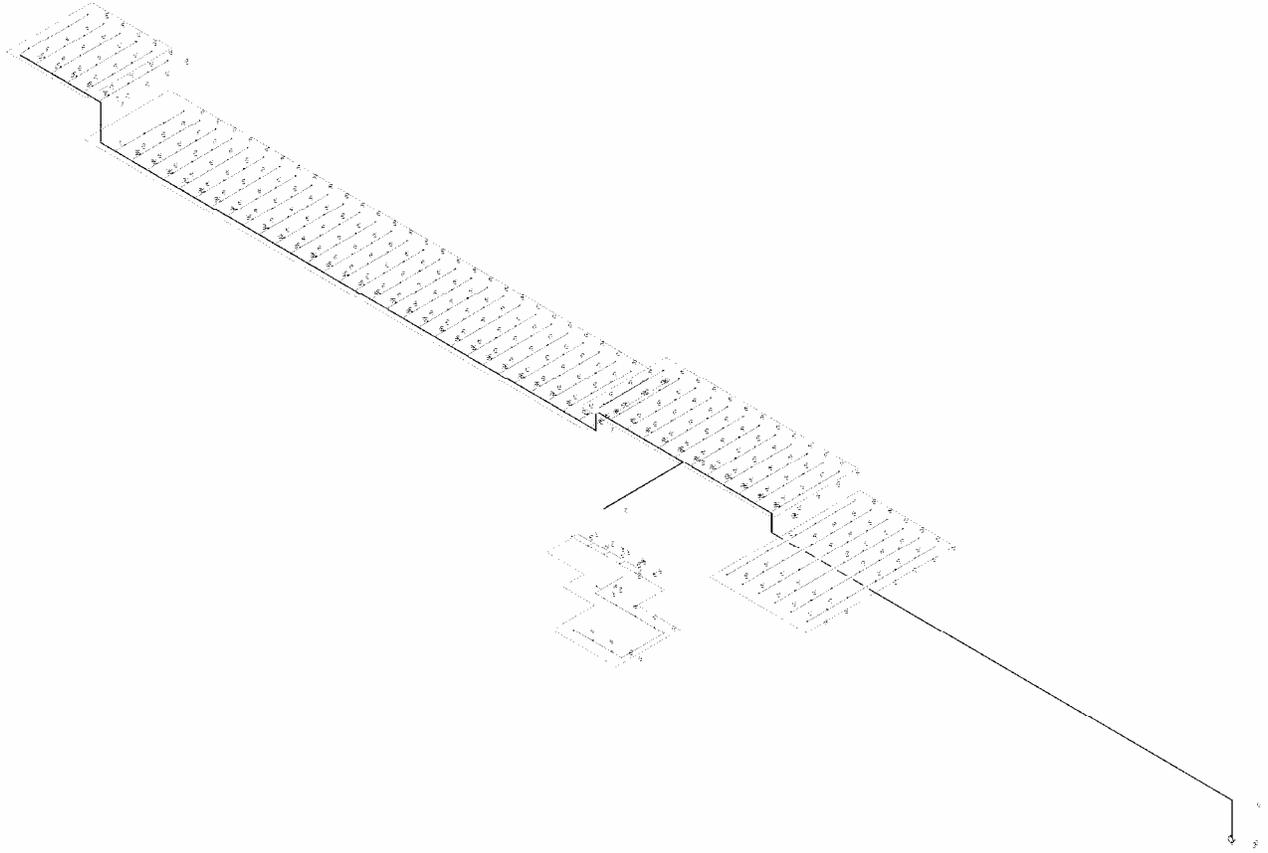
Figure 3. Automatic Fire Sprinkler System Hydraulic Analysis Node Diagram

- 8.1 An hydraulic analysis was completed of Installation 3 in the press hall. Refer to Figure 3 for the configuration of the sprinkler pipe work. The analysis was based on a water supply test completed on the diesel primary pump at the sprinkler system valve house. NZFS hydrant and hose stream demands were not taken into account.

- 8.2 The hydraulically remote design point of the automatic sprinkler system at the roof of the press hall was at the western end of the press hall above the pendister. Analysis of the remote area showed that the system was capable of achieving a minimum design density of 7.38 l/min over 216 sq m. The performance exceeded the minimum 5 mm/min over 216 sq m design requirement.

- 8.3 A further analysis was completed of the automatic sprinkler protection around the perimeter of the press pit. The seven sprinkler heads had a minimum design density of 5.82 mm/min based on maximum head coverage of 12 sq m per head. The automatic fire sprinkler protection in the area is considered to be localized, application specific, requiring concurrent operation of all seven heads. The available density exceeded the minimum design density of 5 mm/min over the out-feed end of the press pit.
